# The Menace of Widespread Gully Erosion in Southeastern Nigeria: Litho-Anthropogenic History and Management and Policy Issues

## Abstract

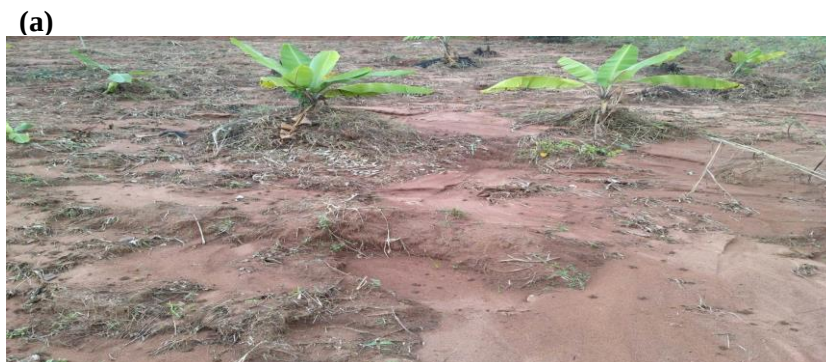
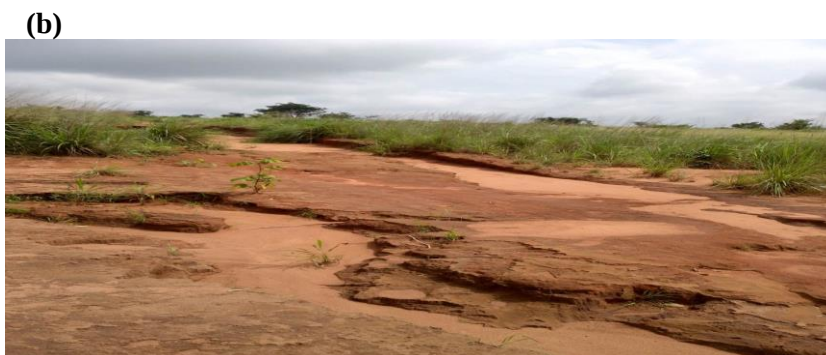
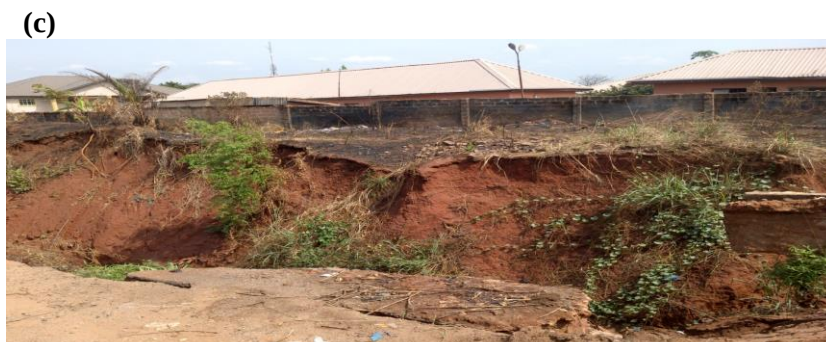
**Plate 1:**

Pictures related to  
(a) interrill (sheet) erosion  
(b) rill erosion and  
(c) gully erosion in the  
study area (Photo taken by  
Okenmuo, F.C.)

The environment in southeastern Nigeria is characterized by dispersible soil and geology, deforestation, heavy rainfall, climate and landscape changes, land misuse and increased built-up areas (Ofomata, 1981; Igwe, 2012; Udokporo *et al*, 2015; Nnabude *et al.*, 2021). The combination of the hazards and vulnerable conditions results to ecological disasters as illustrated in Figure 1. The resultant soil erosion is caused by a lowered soil surface ability to withstand the increased pressure from erosive forces acting on land surface. The phenomenon is classified as interrill (sheet), rill or gully based on its degree and form (Plate 1).

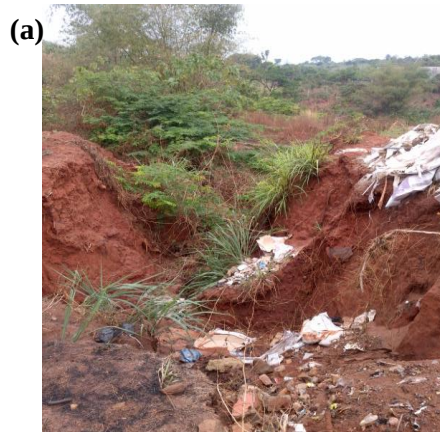
**Plate 2:**

- a.** Refuse disposal at a gully site
- b.** Gully erosion on an abandoned sand mining site

As forests and sand deposits become a source of community revenue, they are often exploited without consideration of the negative impact (Plate 2b). Nnabude *et al.* (2021) noted that most of the excavations during sand mining were never filled up but left to become hollows and gullies. Also, when road infrastructures are constructed without drainages or inadequate drainages for the volume of water passing through it, soil erosion channels begin to appear. The gullies (active) expand with each rainfall, extending for kilometres with depths in tens and hundreds of metres as observed in Abagana, Awka, Enugwu-Ukwu and Nanka areas, as observed during fieldwork by the authors in 2019.

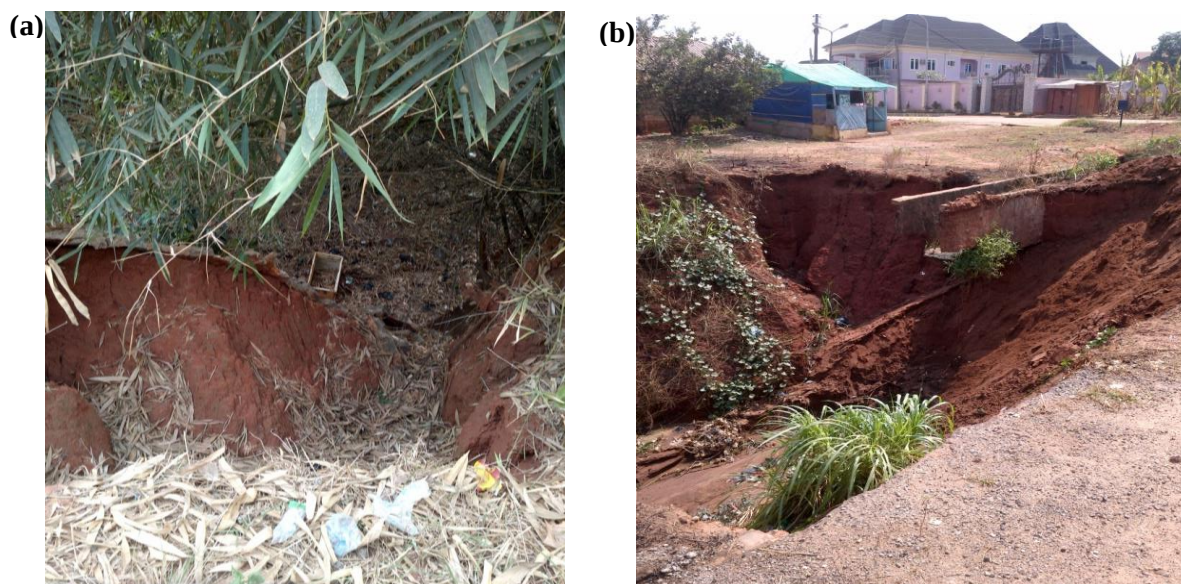
**Plate 3:** Examples of failed conservation measures in Anambra State

**a.** Bio-structural measure failure at Enugwu-Ukwu **b.** Failed horizontal drainage channel at Awka
